The Manistee Lake Improvement Program – A Successful Collaboration

By: Tony Groves
 Water Resources Practice Leader
 Progressive AE

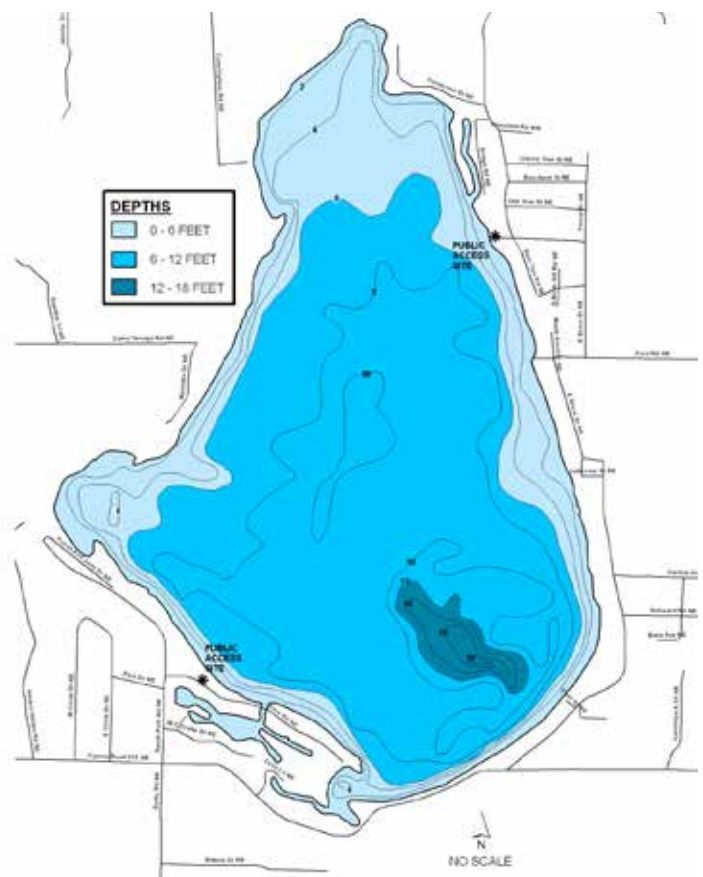
Figure 1 - Manistee Lake Depth Contour Map

With a surface area of 876 acres, Manistee Lake is a relatively large lake. However, despite its size, the lake is shallow with a maximum depth of 18 feet, and a mean or average depth of about 7 feet (Figure 1). Much of the lake is shallow enough to support aquatic plant growth. The shoreline of Manistee Lake is over 7 miles long.

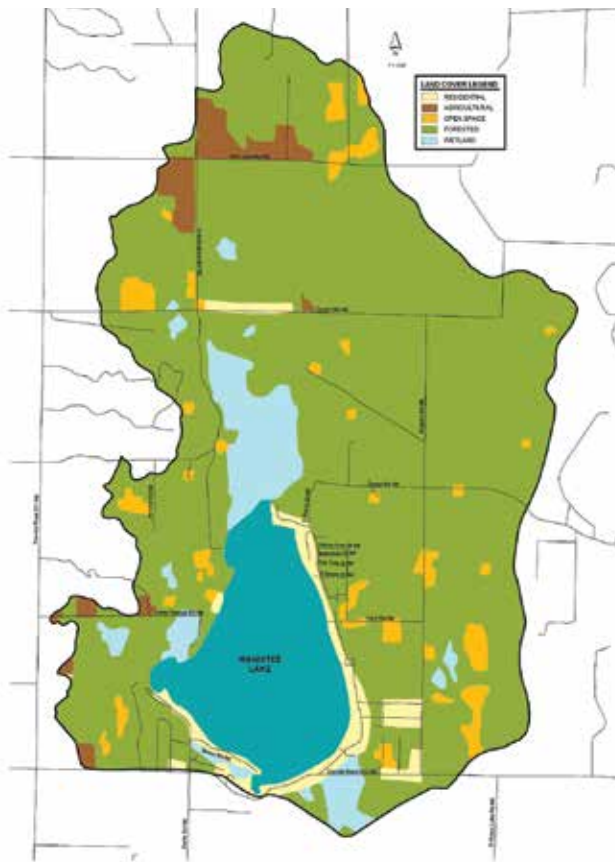
Figure 2 – Manistee Lake Watershed Land Cover Map

The Manistee Lake watershed is approximately 6,600 acres in area, a land area about 7.5 times larger than the lake itself. Much of the watershed is forest or wetland. However, most of the land

immediately adjacent to the lake has been developed (Figure 2). Currently, over 300 homes and cottages border the lake.

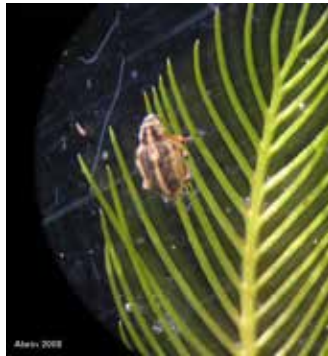
Figure 4 - The Milfoil Weevil (*Euhrychiopsis lecontei*)

In order to control the spread of Eurasian milfoil, milfoil weevils (*Eurhychiopsis lecontei*) have been stocked in Manistee Lake on a periodic basis since 1999 (Table 2, Figure 4). In total, 138,000 weevils have been stocked and additional stocking is planned. The weevils feed exclusively on milfoil species, especially Eurasian milfoil. Researchers have documented declines in Eurasian milfoil in some lakes as the result of weevil feeding. These declines have been attributed largely to the burrowing and tunneling action of weevil larvae that cause the milfoil plant to lose buoyancy and fall from the water column. It is hoped that continued stocking in Manistee Lake will result in a sustained weevil population sufficient to provide long-term milfoil control. The annual vegetation monitoring surveys are being used to evaluate the efficacy of the weevils in controlling milfoil.

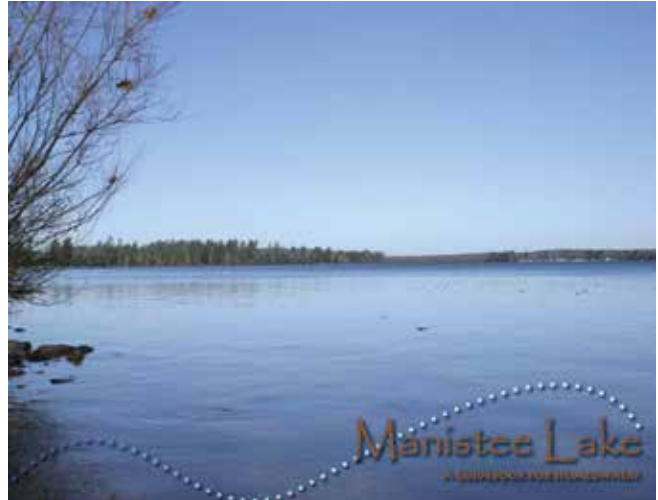
Figure 5 - Manistee Lake Guidebook for Homeowners

lakeside lawn care, fertilizer use, greenbelts, rain gardens and other practices to protect the lake (Figure 5). Copies of the guidebook were mailed twice to all property owners around the lake.

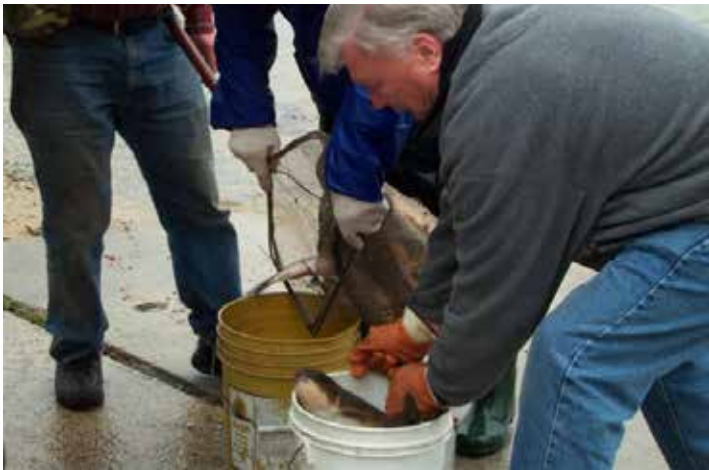
Figure 6 – Manistee Lake Sucker Removal

Recent DNR survey results indicate that about 50% of the total fish biomass in Manistee Lake is white suckers. White suckers often compete with perch and other fish for food. In an attempt to reduce the number of white suckers, the Manistee Lake Improvement Board and the Manistee Lake Association worked with the DNR to obtain permits to conduct a white sucker netting program. Beginning in the spring of 2007 and continuing each spring from 2010 to 2012, several thousand white suckers were netted and removed from the lake as they moved into the shallows to spawn (Figure 6). Captured suckers were distributed to the public free of charge. The DNR is planning additional surveys of Manistee Lake to evaluate the overall health of the fishery and the effects of the white sucker removal program. As this project moves forward, the Manistee Lake Improvement Board and the Manistee Lake Association are planning to continue periodic spring sucker netting and are exploring methods to enhance natural walleye reproduction in the lake, perhaps through the construction of artificial spawning reefs.
